THE PLACING OF LINE SURGE ARRESTERS AND FUSES ON 11 AND 22 KV LINES TO PROTECT EQUIPMENT AGAINST LIGHTNING

Thesis presented in partial fulfilment of the degree
M.Eng. at the University of Stellenbosch
March 2001

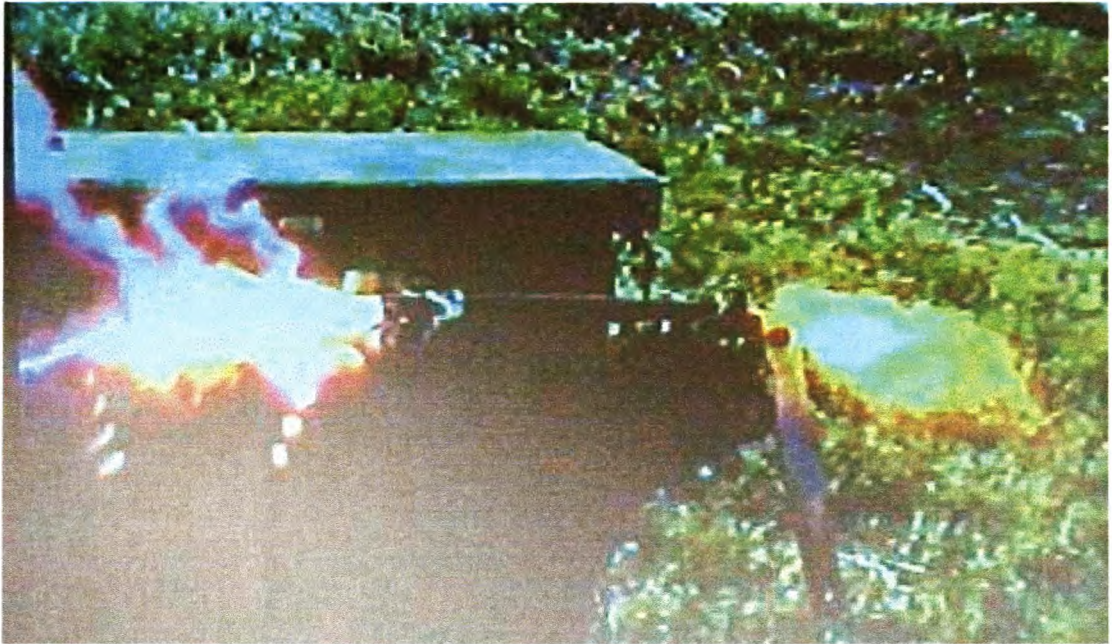
Figure 1.2. Arcing during fuse (standard type) operation.

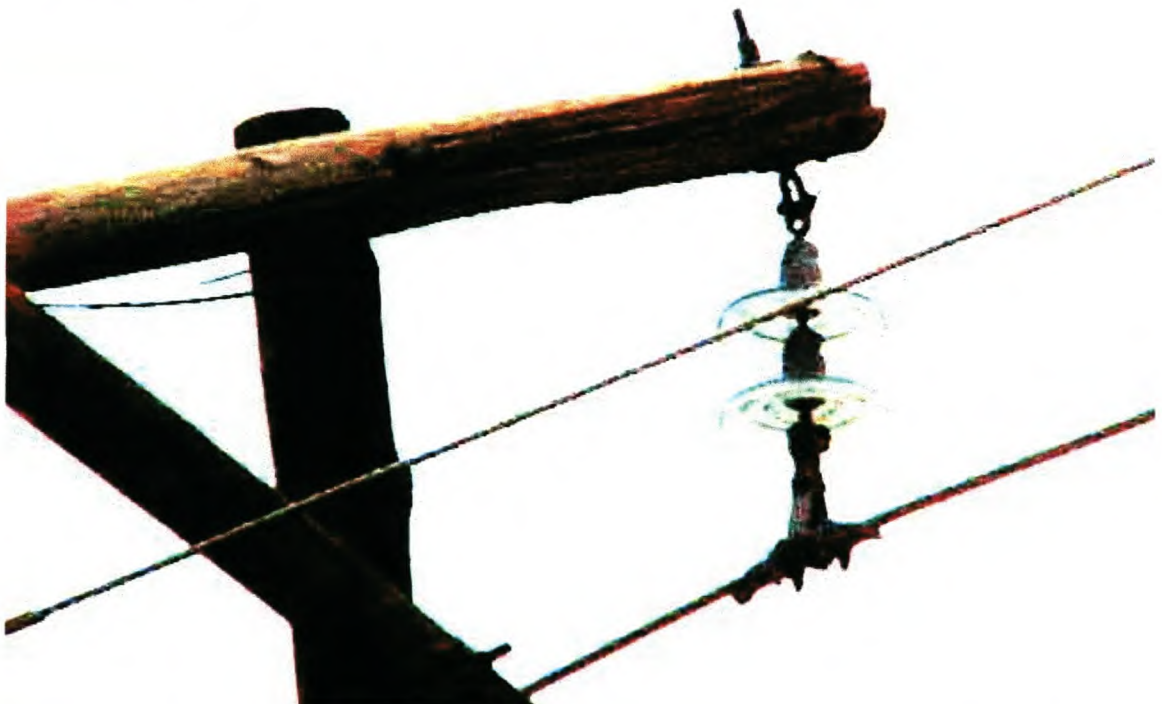
Figure 1.8. Pole splitting. The lightning damage can be seen on the right top end of the cross arm.

A direct lightning stroke on the line discharges currents in the range between 7 and 10 kA through the pole to earth [11]. This can cause the pole to splinter (figure 1.7) or split (figures 1.8 and 3.1.2)

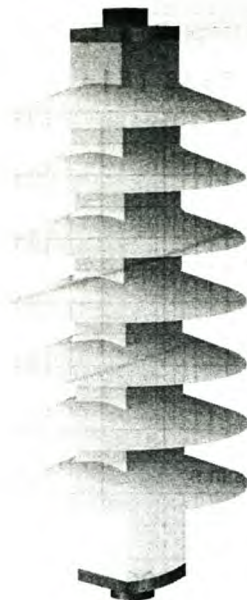
Polim-D..N Technical Data

With ABB metal-oxide resistors without spark-gaps

With one line discharge 1.5 kJ / kV_{uc}

Energy at one high current impulse
100 kA 4/10 μ s. 3.6 kJ / kV_{uc}
(as tested in the operating duty test)

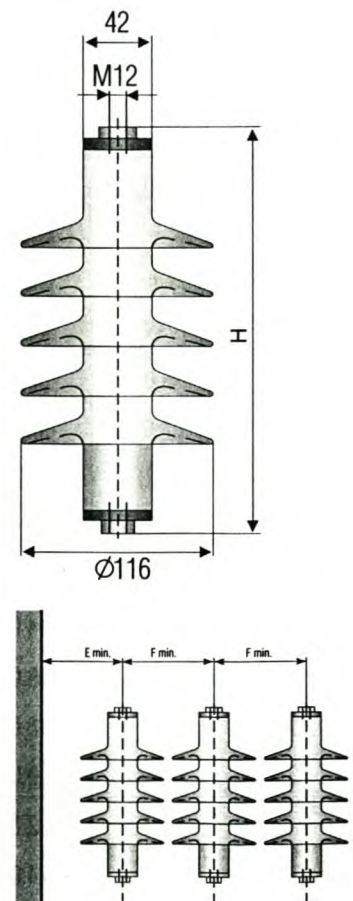
Insulation Data, Dimensions, Weight

Type	Creepage distance	Flashover distance	Minimum clearances		Height H	Weight	Insulation withstand voltage on empty housing			
							BIL 1.2 / 50 μs		50 Hz 60 s wet	
POLIM-D..N	mm	mm	E min mm	F min mm	mm	kg	Min. Values acc. to IEC kV	Gar. Values acc. to tests kV	Min. Values acc. to IEC kV r.m.s.	Gar. Values acc. to tests kV r.m.s.
04	153	121	73	100	144	< 0.8	18.2	78	8.3	20
06	153	121	96	121	144	< 0.8	27.3	78	12.4	20
08	306	170	118	143	191	< 1.2	36.4	110	16.6	28
10	306	170	140	165	191	< 1.2	45.5	110	20.8	28
12	306	170	162	186	191	< 1.2	54.6	110	24.9	28
14	460	217	184	208	239	< 1.6	63.7	140	29.1	38
16	460	217	207	230	239	< 1.6	72.8	140	33.2	38
18	460	217	229	251	239	< 1.6	81.9	140	37.3	38
20	610	264	251	273	286	< 2.2	91.0	170	41.4	50
22	610	264	274	295	286	< 2.2	100.1	170	45.6	50
24	610	264	296	316	286	< 2.2	109.2	170	49.8	50
